MECHANICAL TESTING LABORATORY REPORT – No.: 1-M-398299

The castor supplied and identified above **complied** with AS 1576.2-1991 Appendix H.

Description of Test : **Compression Testing of 700kg Castor**

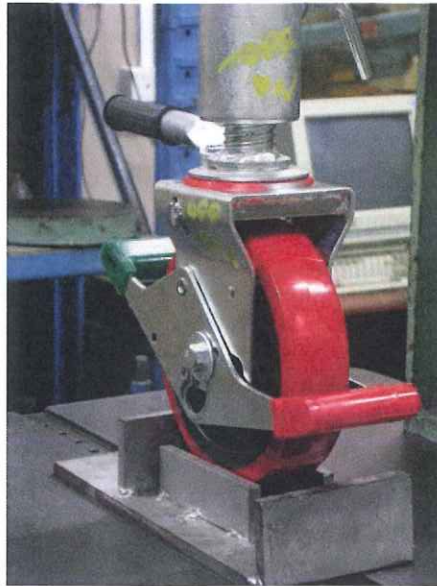
Figure 1: The loading of the castor in the test machine

The assembled castor was loaded at 1.5 times and 3 times the rated load for 15 minutes each. The brake on the castor was applied during the testing.

The method of loading the castor is shown in Figure 1.

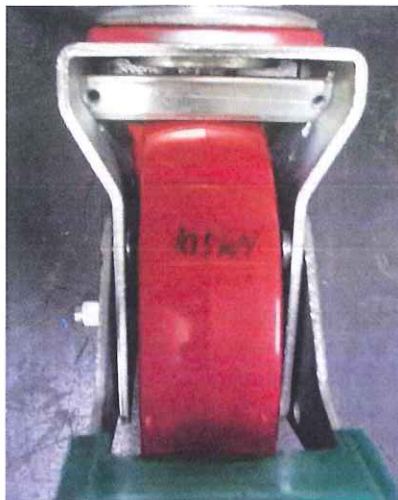
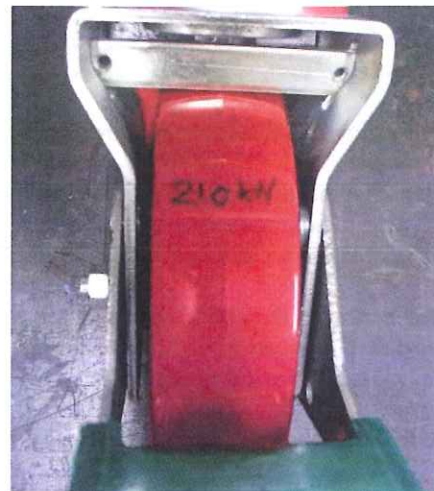
Indentations due to the application of the brake were observed on the wheel after each stage of testing. This is shown in Figure 2.

Figure 2: The depressions on the wheel after the application of the load. The load applied for the impression shown is marked on the photograph: 10.5kN for 1.5 times the rated load and 21.0kN for 3 times the rated load
